1.2.2 Range 20, Infiltration Course, Parcel 76Q-X

1.2.3 Range 23, Trainfire (Record) Range, Parcel 79Q

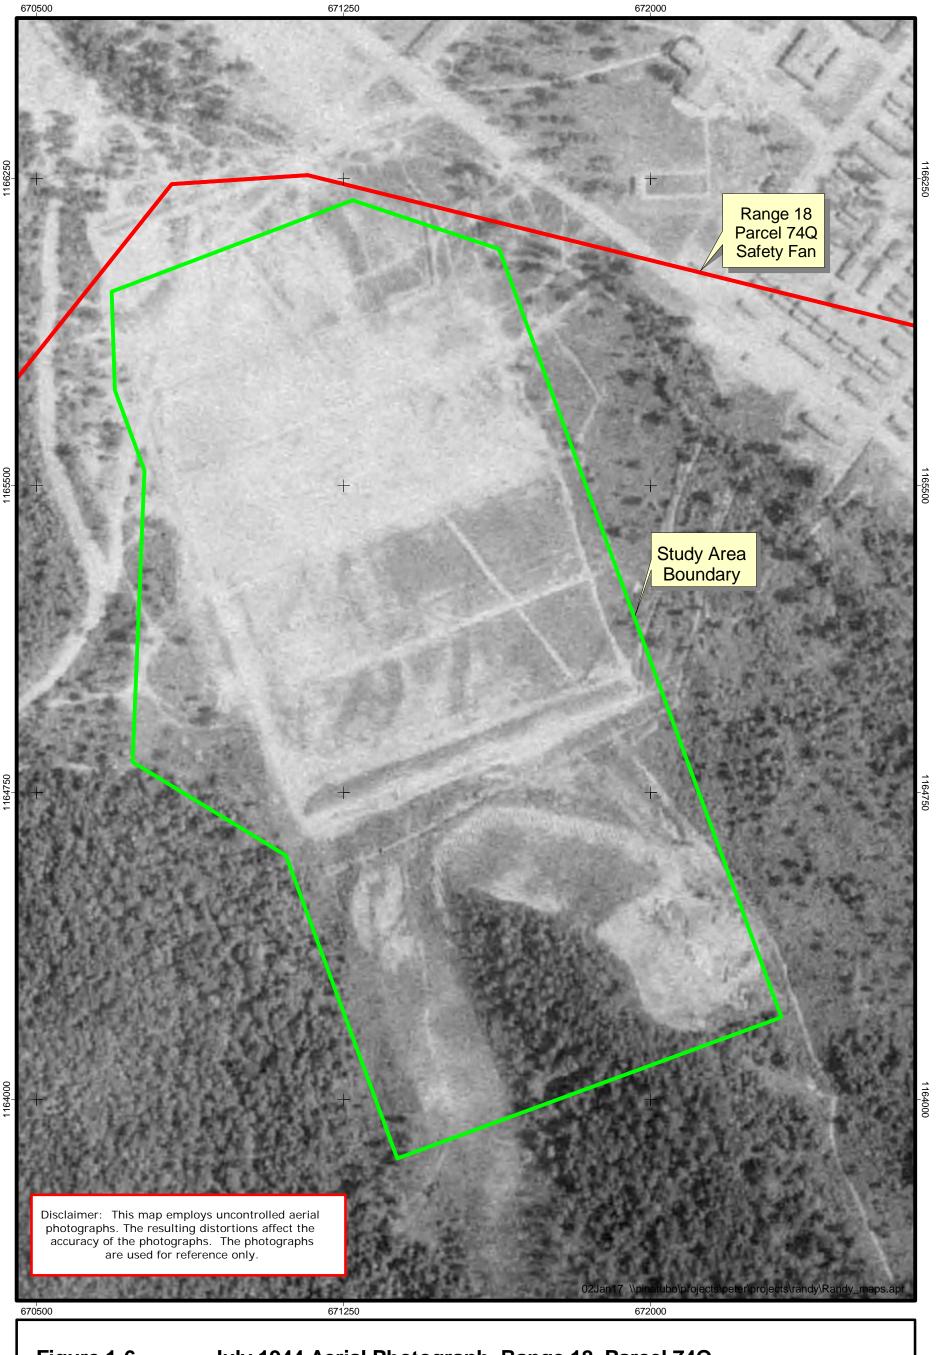
Figure 1-6

July 1944 Aerial Photograph, Range 18, Parcel 74Q

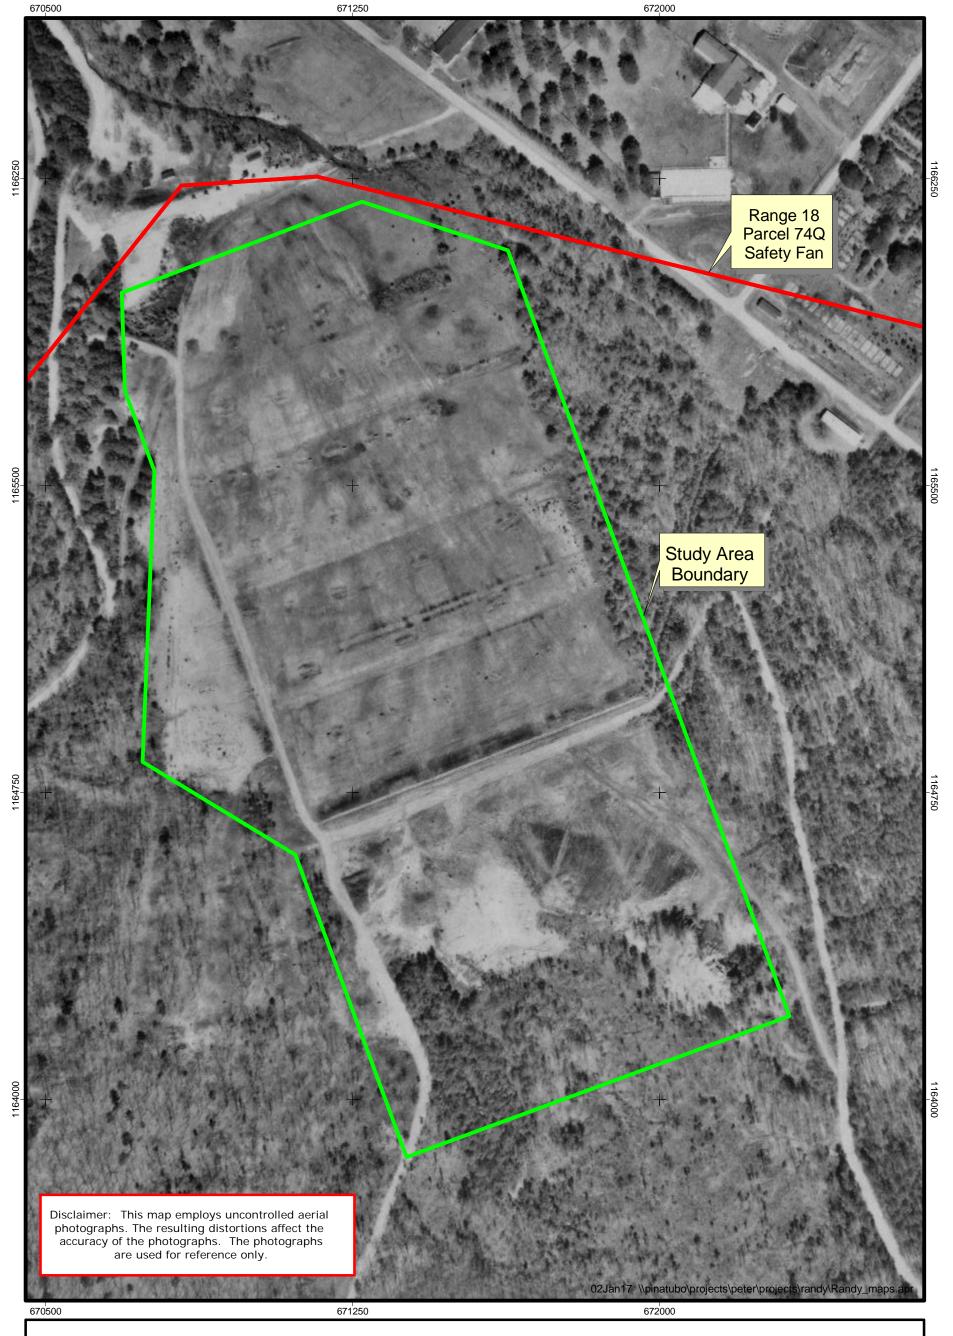
Figure 1-7 March 1973 Aerial Photograph, Range 18, Parcel 74Q

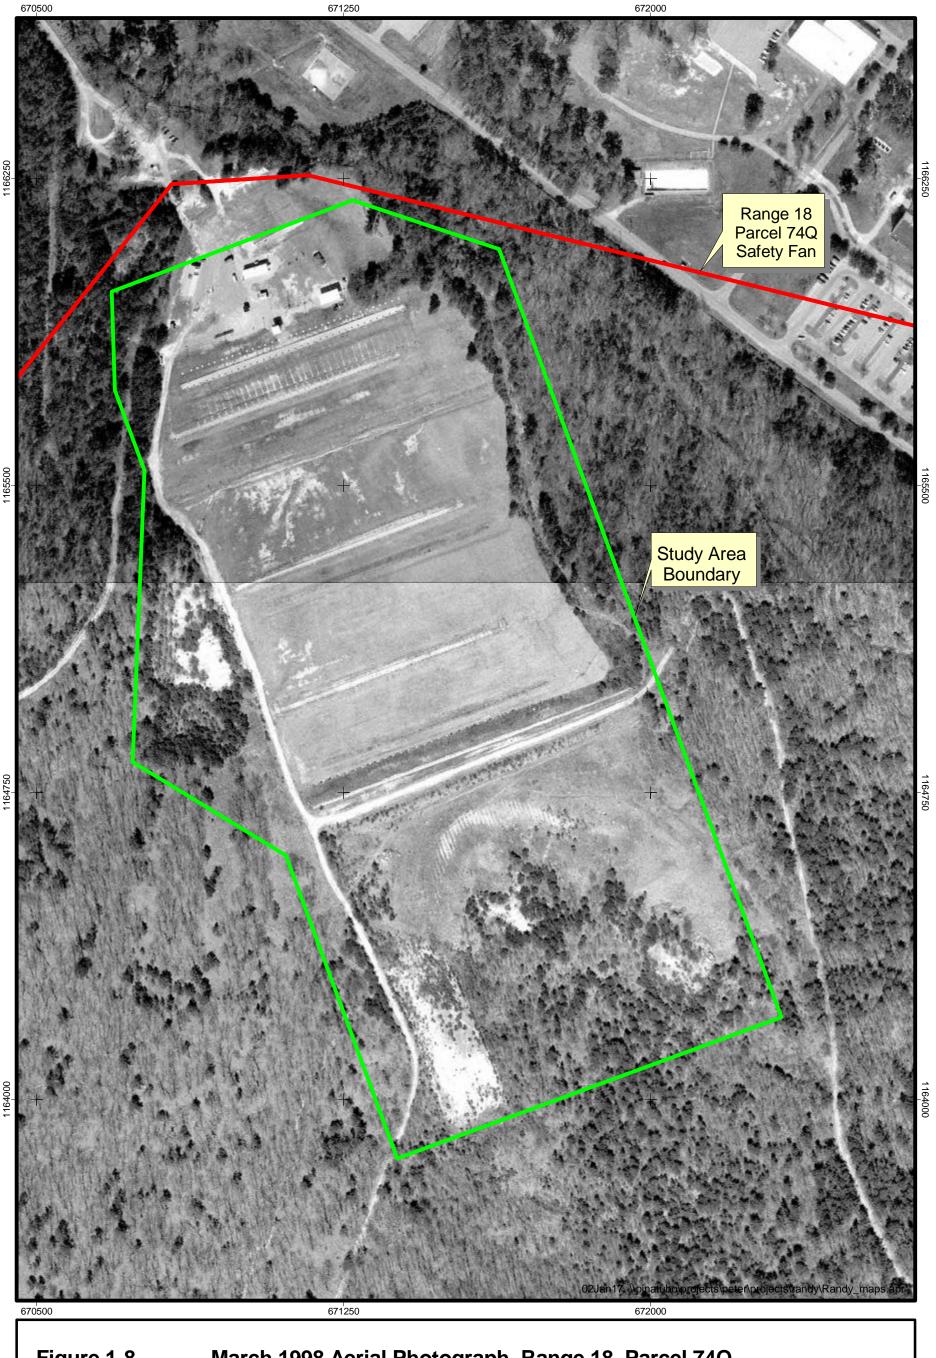
Figure 1-8

March 1998 Aerial Photograph, Range 18, Parcel 74Q
